LAKE IRENA DAM

NDI ID NO. PA-00179
DER ID NO. 40-215

PHASE I INSPECTION REPORT NATIONAL DAM INSPECTION PROGRAM

SEPTEMBER 1981

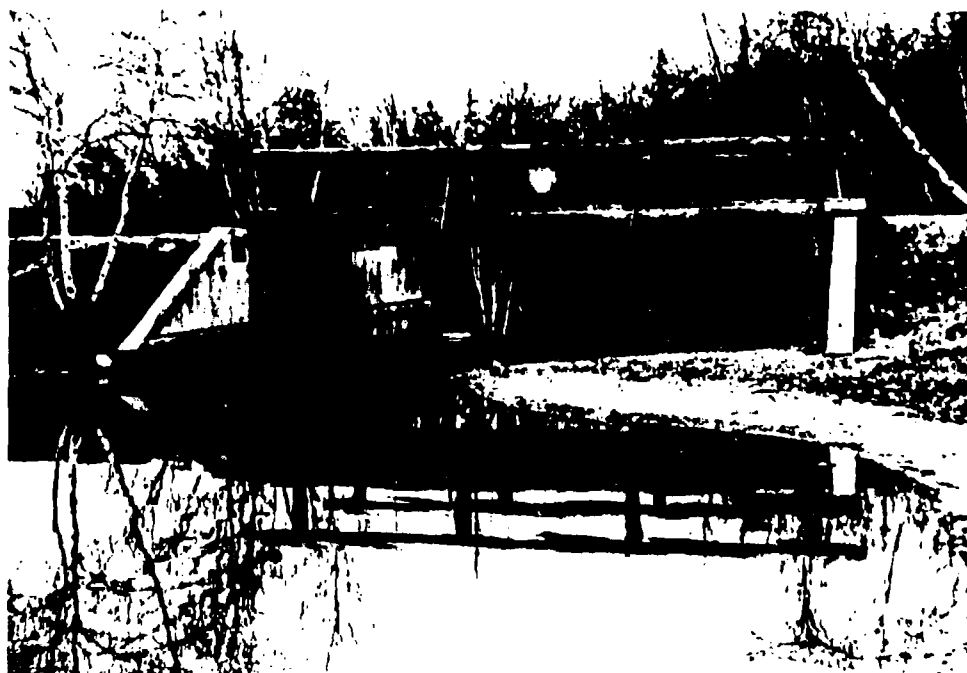
8. Spillway approach, walls and bridge.

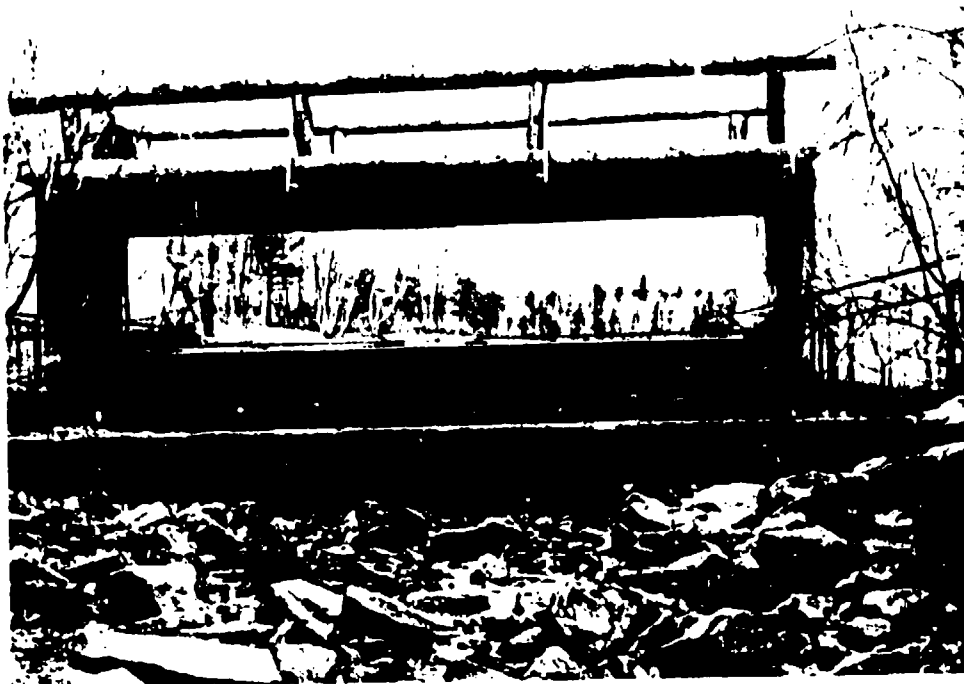
9. Spillway bridge, weir and discharge channel.

7. Make appropriate repairs to the spillway bridge to assure that no damage is done to the spillway by the passage of traffic.
